By appointment to
Her Majesty The Queen
Building Façade Restoration
and Conservation

Holy Trinity Maidstone

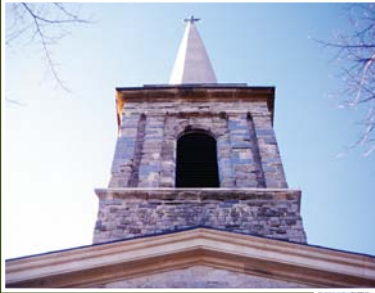
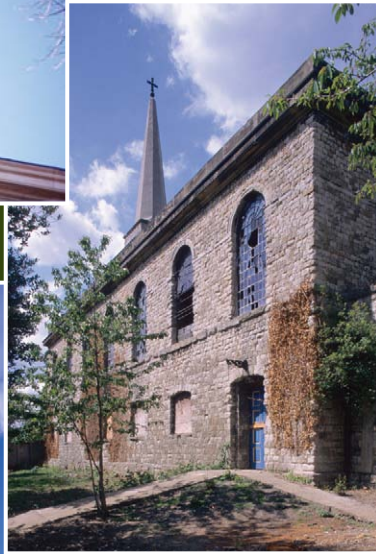
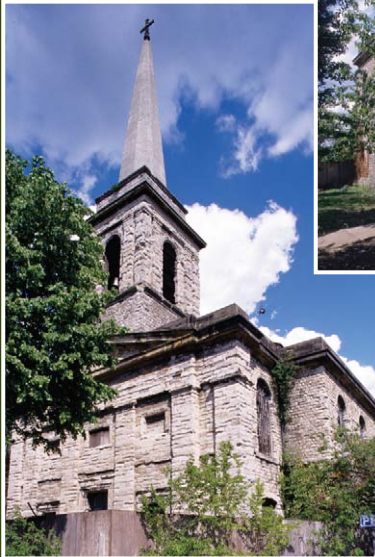
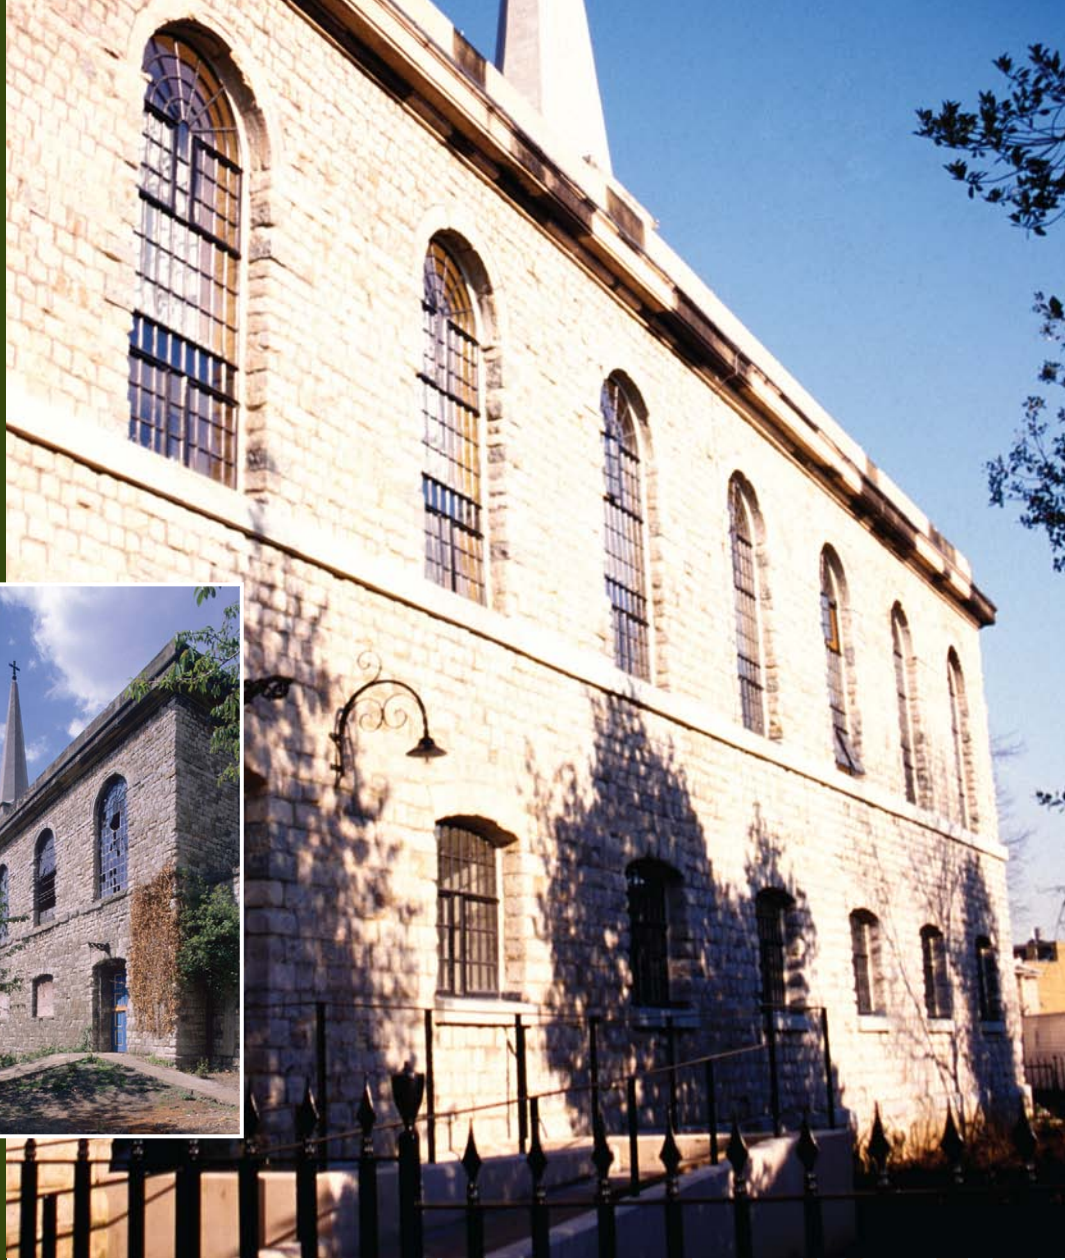
Redundant since 1974, the church had been seriously damaged by arson, fallen into disrepair, and had been heavily vandalised. The more exposed areas of the church such as quoins, cills, capitals and string courses suffered from weather damage and had to be replaced with newly carved stone. Kentish ragstone was a popular church building material in the 19th century but because it is very hard and variable, it is difficult to work.

Long neglected skills had to be resurrected by our stonemasons to repair the famous Maidstone Landmark, Holy Trinity Church. Our masons had to use 19th Century stone cutting techniques to replace weather damaged Kentish ragstone in the 1827 Grade II listed building.
