71 Lombard Street

Major external masonry repair work carried out to the façade of the Lloyd's TSB Bank headquarters for Bovis Europe and Ove Arup & Partners by PAYE Stonework & Restoration, highlighted structural problems that could prove a multi-million pound headache for owners of similar London buildings.

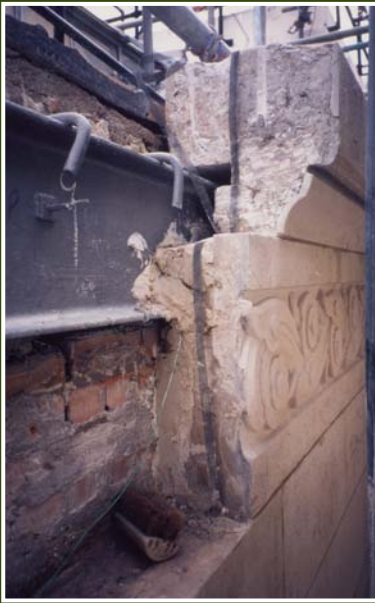
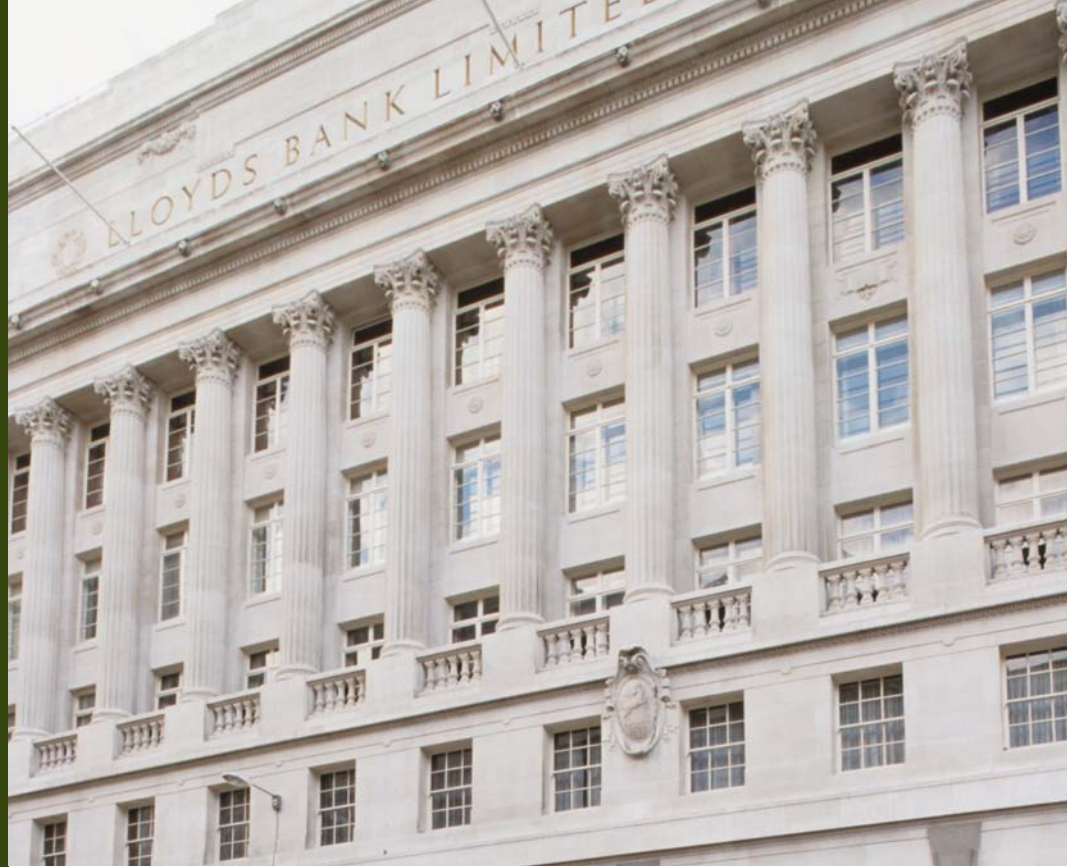
The Lombard Street Grade 2 listed building, designed by Thomas Tait and constructed between 1927 and 1929, incorporated a steel frame over which Portland Stone cladding had been erected. Corrosion within the steel beams caused fracturing and displacement of the stone masonry. The Department of the Environment has estimated that hundreds of steel-framed buildings built between 1908 and 1939 could be suffering from similar corrosion problems, generating potential repair bills in excess of £300 million.

PAYE masons have carefully cut out and matched all the defective Portland Stone on both the Lombard Street and Cornhill elevations. Before replacing the damaged sections of ashlar façade, the company's repair experts had to halt the corrosion to the old steel framework which they exposed by preparing and applying modern anti-corrosion compounds. In addition, PAYE has installed cathodic protection to parts of the outer façade judged to be at most risk. This computer controlled system passes low voltage currents throughout the stonework to create a corrosion retarding electronic field around the steel framed members at risk.
