Maiden Lane Canal Bridge

As part of a project to reconstruct the Victorian Maiden Lane bridge over the Grand Union Canal in London experts from PAYE Stonework and Restoration rescued quoins, the bridge corner stones which have been scored with rope marks by the original barge traffic. These silent witnesses to a slower form of commercial transport were reused in the strengthened bridge.

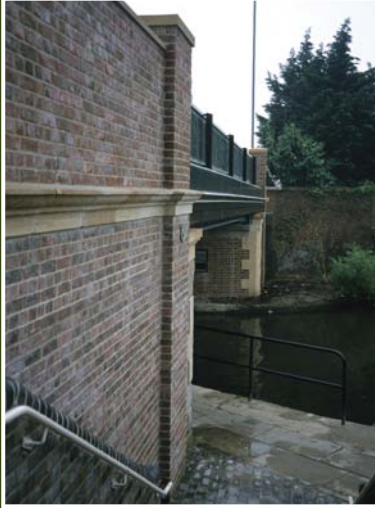
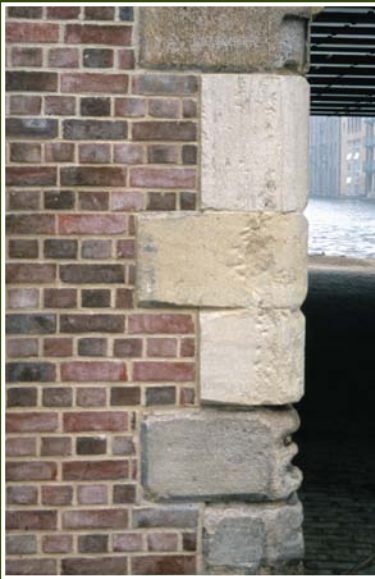
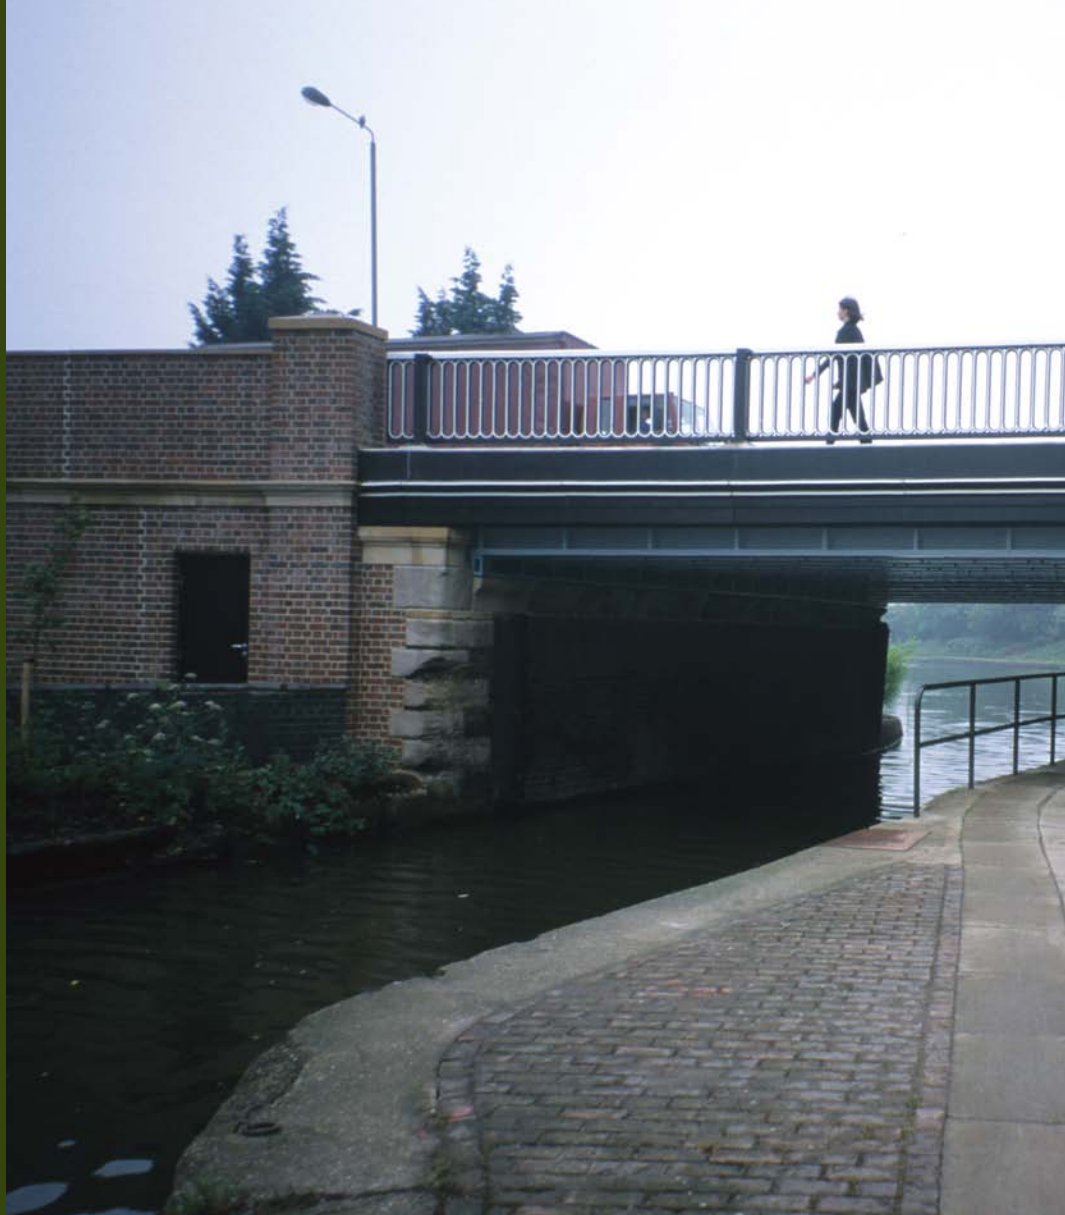
The bridge was widened with new decking on a prefabricated steel beams. The stone cornice which topped the brick parapets leading to the bridge was salvaged then cleaned and restored.

New stones for badly deteriorated sections of the bridge had to be matched and cut to fit. To assist the integration of the modern day stone, one complete corner of the bridge was re-built with new blocks, releasing original material for incorporation in the other corners.
