By appointment to
Her Majesty The Queen
Building Façade Restoration
and Conservation

68 King William Street

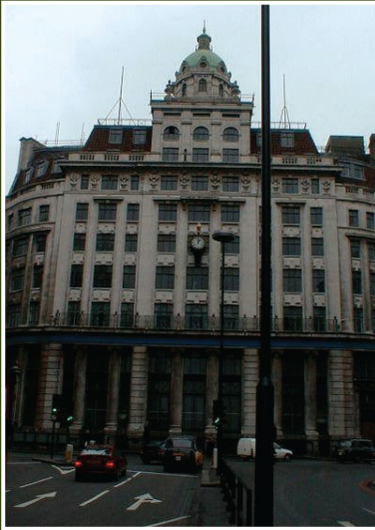
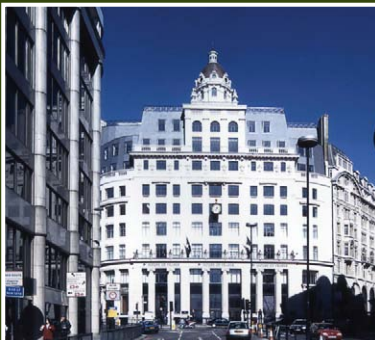
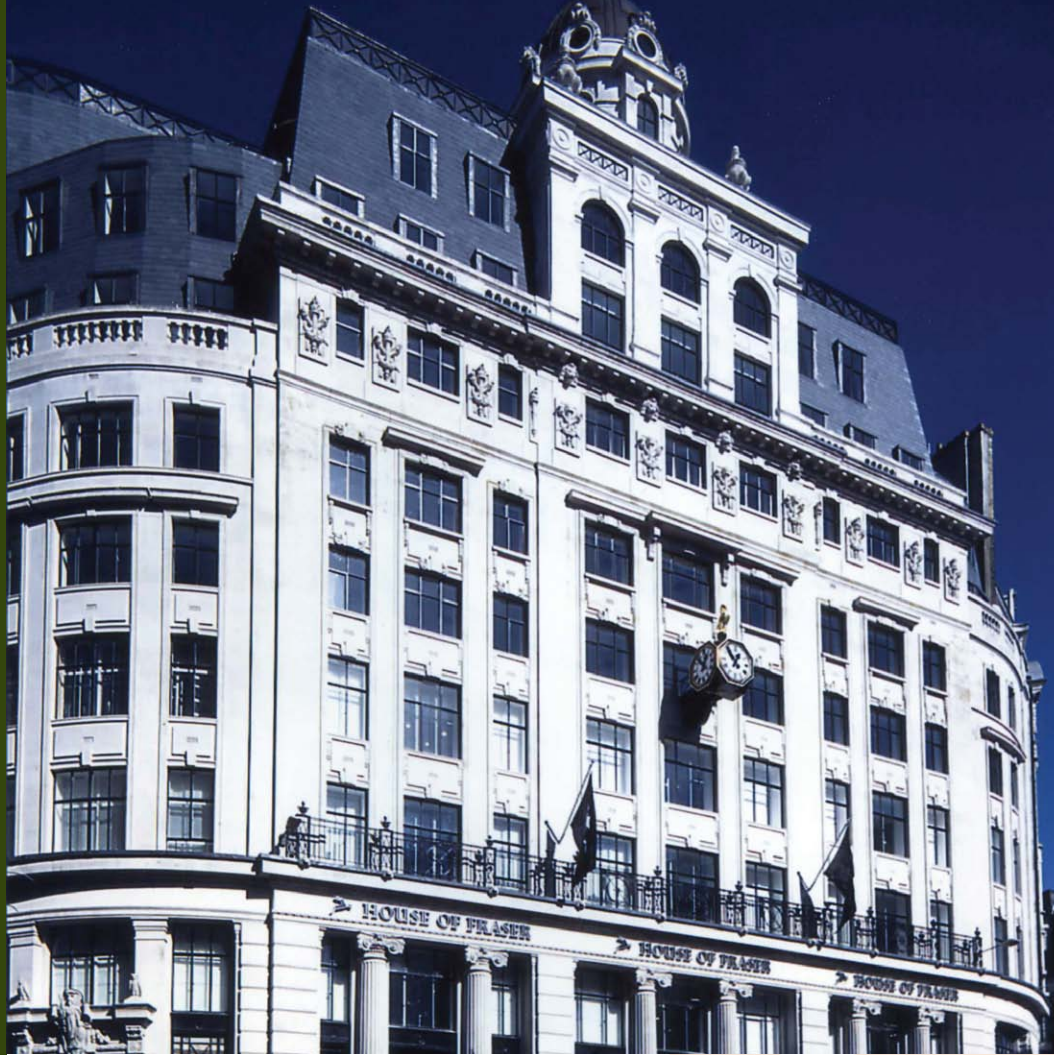
This project involved the partial dismantling and off-site storage of the masonry forming the cupola and top three storeys. The stone was carefully dismantled after detailed surveys had been undertaken to the satisfaction of architects Elsworth Sykes and English Heritage. Salvaged stone was carefully protected and stored off-site for several months before being returned to site for reconstruction.

To overcome the problem of providing modern offices behind historic facades where the existing storey heights are too low, the top three floors were reconstructed introducing additional courses of carefully selected matching Portland Stone to stretch the storey heights to modern acceptable levels. Existing cornices and other decorative features were reused. New stainless steel restraint fixings were introduced to tie the reconstructed facade to the new backing structure. This principle was developed with structural engineers Peter Brett Associates.

The retained section of facade at lower levels was cleaned using controlled volumes of water delivered by means of fine nebulous water sprays. Corroding steel framed members were also exposed and treated - carefully selected matching Portland Stone and Scottish Kemnay granite were used for repairs and main entrance adaptations.
