By appointment to
Her Majesty The Queen
Building Façade Restoration
and Conservation

Hove Methodist Church

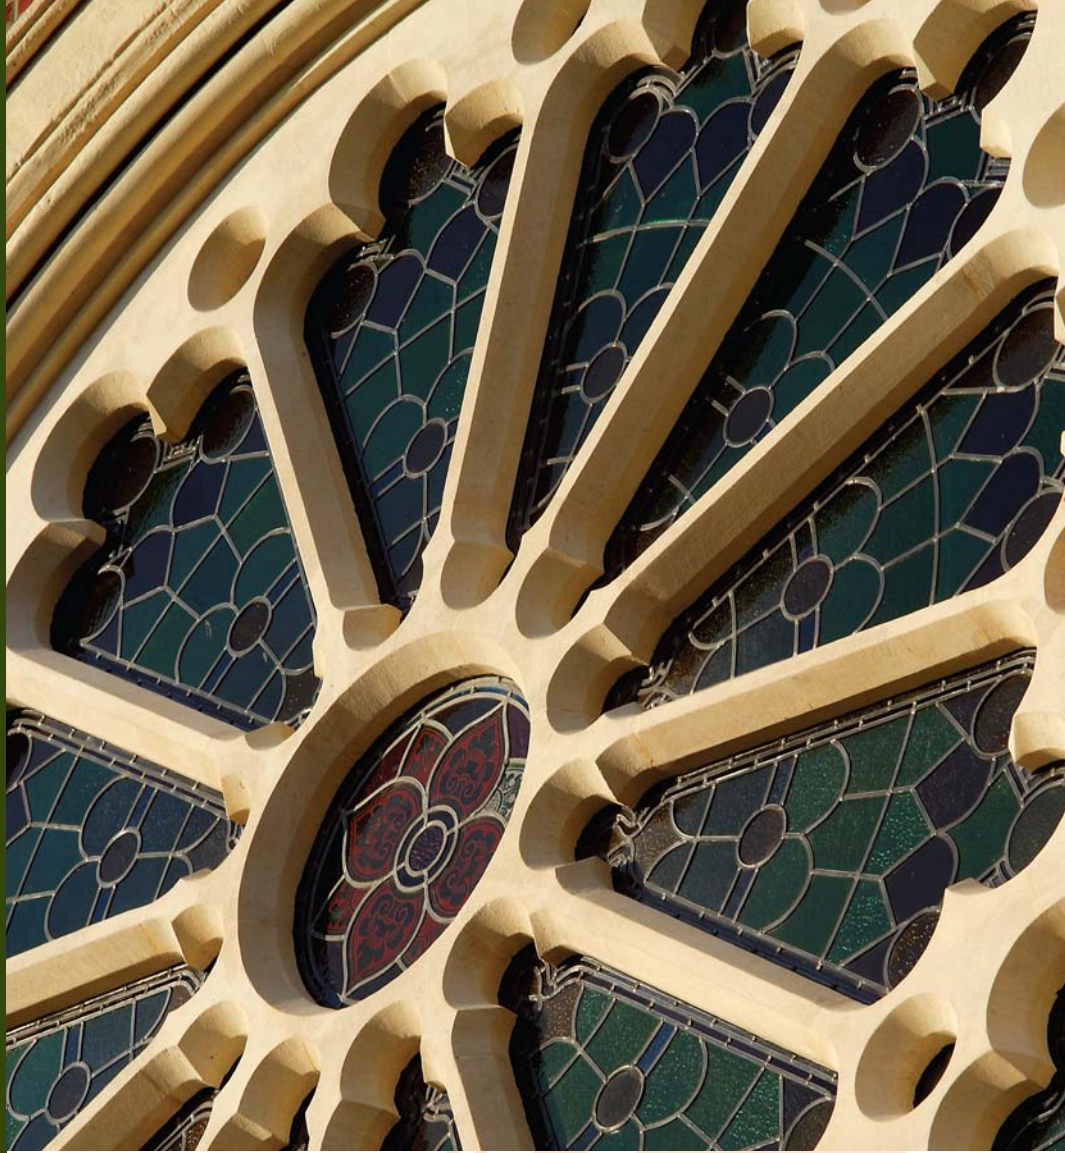
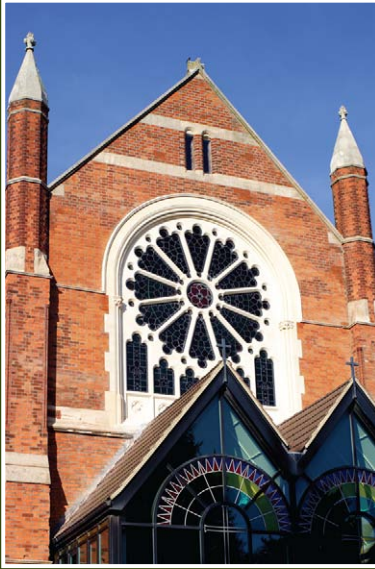
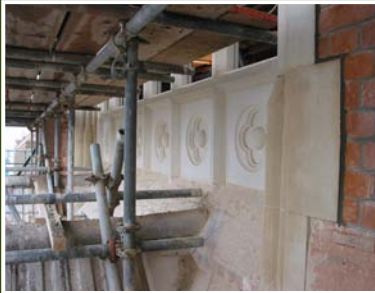
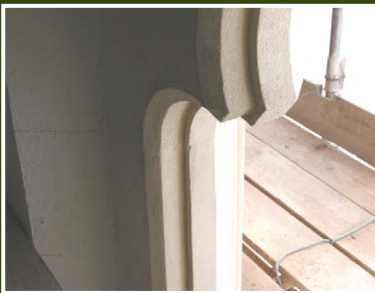
The Rose Window to the church was in poor condition, heavily eroded and the leaded lights were leaking. PAYE Stonework were appointed to complete a full replacement of the Bath Stone window including the re-leading and repair of the stained glass.

The complex masonry works had to be completed whilst supporting the gable structure above and included the repair of the gable.

Whilst on site repairs were completed to the other elevations including the replacement of original hoop iron ties with new stainless steel elements.
